Manhole Inspection Summary

Manhole # S57K__011MH

Insp Date: **5/14/08 2:11 PM**

Location Address: **3916 foster ave**

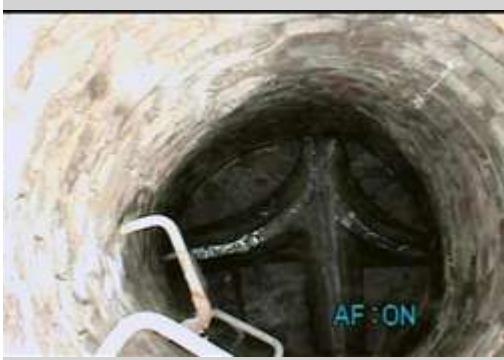
Defect 1

Steps Count: **5** Missing: **0** ☒ **Corroded**

corroded steps

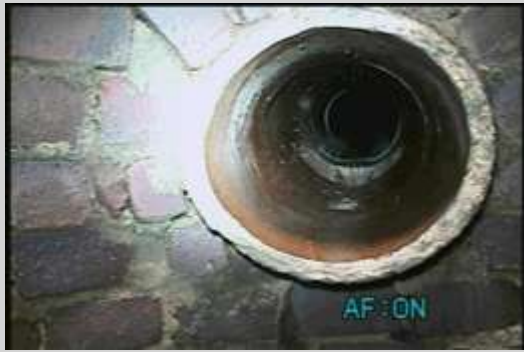
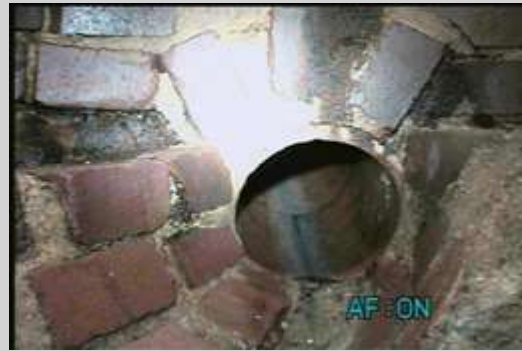
6 O'Clock Inflow

Comments **drop is draning into soil befor manhole wall**

draining behind manhole wall

Drop: **Outside Direct**
